NOTIFIER TECH TIP

AFP2800

0.2.i2 "PANEL GROUND FAULT"

V1.0 CH 14/04/17

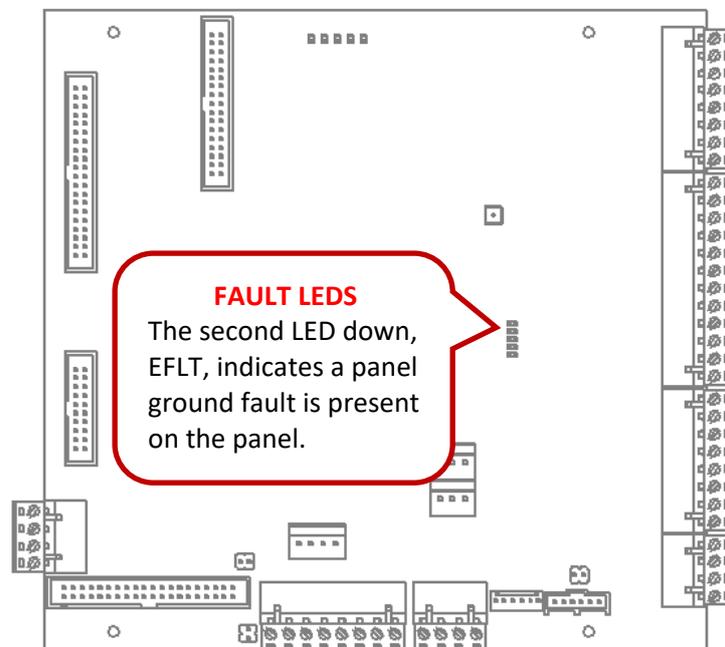
Where enabled, the AFP2800 will display this earth leakage as point ID 0.2.i2 with a description of PANEL GROUND FAULT. The point ID 0.2.i2 simply reflects that earth leakage is present on the panel and does not give an indication of where the PANEL GROUND FAULT is located.

The fault will **ALWAYS** be indicated by the second LED down in the group of five fault/status LED's as shown in the diagram below, whether or not "Ground Fault Reporting" has been disabled via the menu system.
